# BUILDING AND SITE ANALYSIS

## HEBER LIGHT AND POWER, HEBER CITY OPERATIONS SITE

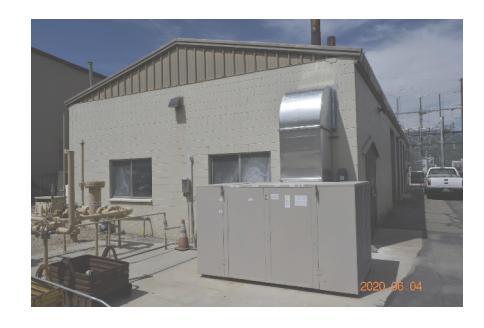
201

Maintenance, mechanical and plumbing operations.
Power plant operators, generator technicians
CMU, exposed insulated metal roofing, concrete floor
Engine oil tank w/ plumbing outlets, water cleaner and purifier, heaters, fluorescent lights, tools and hardware, pumps, electrical junction boxes, HVAC
Engine oil tank is directly plumbed into engines.
• Keep and expand in the future as necessary.

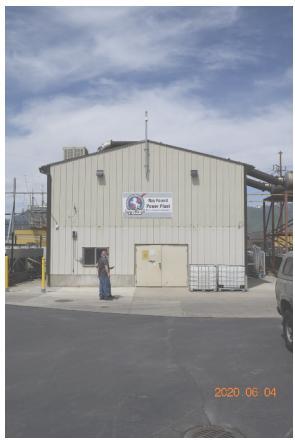
- Roofing redone in 2010 and looks to be in great condition.
- Architectural and structural elements look to be in good condition.

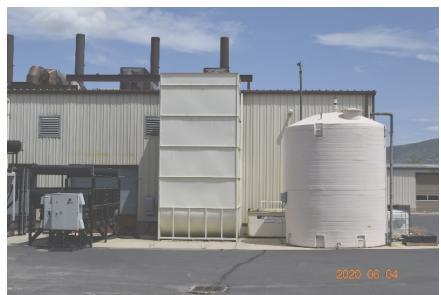
- Architecture and structural elements of the building are in great condition.
- Currently, the power generators in this power plant are the newest and most efficient generators on the campus. Power operations can be significantly expanded by installing additional generators into the fourth, fifth, and sixth bays.

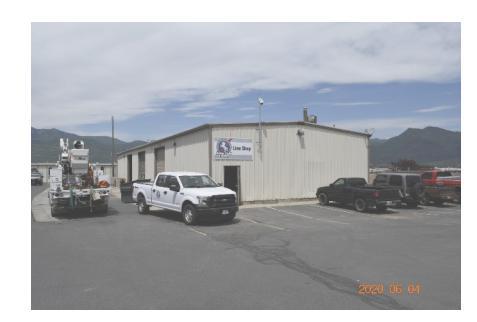
601	
West s	side
Worke	er di

Worker dispatch, training, maintenance
Power line workers, trainees, electricians, servicers
Exposed steel metal framing and roofing with insulation, concrete flooring
Service and dispatch vehicles, training power lines, metal racks, fluorescent lights, equipment storage
Outgrown space - limited working space available.
Practice lines are few and doesn't allow many opportunities for training in teams.
Roof is listed to be redone soon (within next 5 years).
Remove this area and relocate it to a new space for with greater size and scope than currently present.
Include more practice lines for individual and team training.

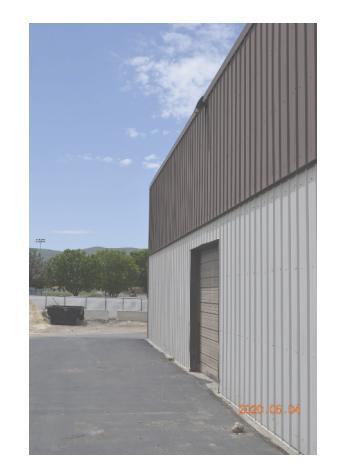
- The warehouse is filled with miscellaneous items that workers couldn't or didn't want to find a place for.
- The building has no insulation or heating equipment, making it ill-suited for temperature sensitive items that might be stored there.
- With no foundation footing on the east side, the building is a seismic hazard and endangers all personnel who go in there as well as the item stored in there.
